## Assessment of Regulatory Compliances in Diagnostic X-ray Facilities in Tangail District, Bangladesh

Table 1: Necessary safety parameters of diagnostic x-ray facilities

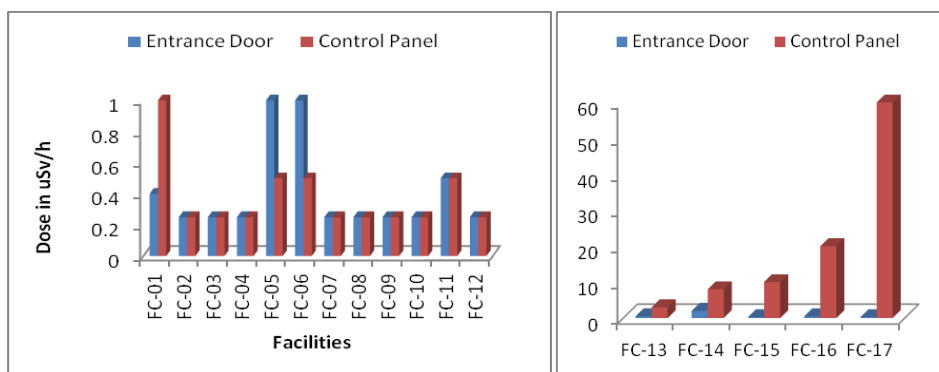
The measured public dose rates at entrance door and control panel for each facility are shown in the Table-1. This table also shows the existing shielding material and wall thickness of x-ray room. It is observed that first 17 facilities are able to shield the radiation properly where shielding structure has been developed following regulatory guide line except the facilities 14-17 as shown in Figure-1. Then in the facilities 18-34, public and occupational workers exposed with extremely higher dose in the range of  $1000\mu\text{Sv/h}$  as shown in the Figure-2. From the collected data, it is seen that, among these 34 installations, only 2 are in compliance nearly with the regulatory requirement with respect to room size of having  $225\text{ft}^2$ <sup>[1]</sup>.

Figure 1: Dose at entrance door and control panel of facilities having shield

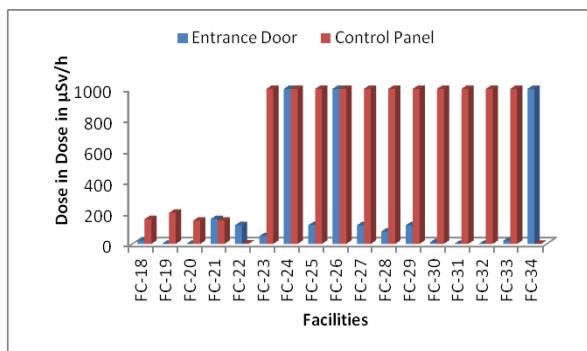
The importance of having shielding material is most necessary for the radiation safety. Collected data shows that 59% of facility use lead (Pb), 3% steel and 38% use nothing as shielding material at the entrance door. In case of control panel, 21% use Pb, 44% brick, and 35% do not have any kind shielding for the radiation.

Figure 2: Dose rate without shielding

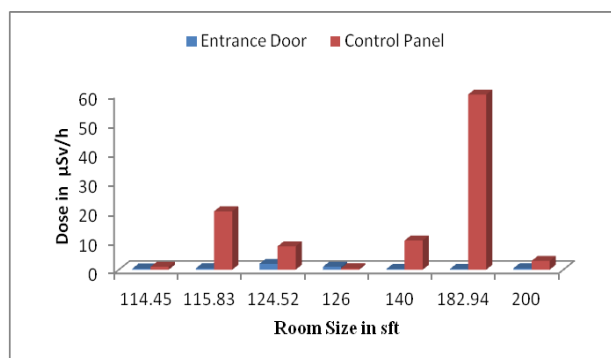
**Figure 3:** Variation of dose rate with room size

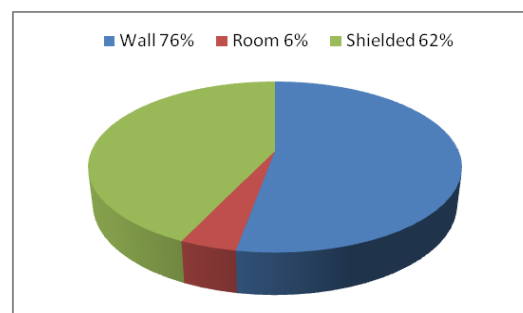
The wall thickness and construction material of the x-ray rooms are also observed in this study. The BAERA rules suggest that every facility should have 10'' brick wall for the x-ray room. From the collected data, it is found that 76% facilities have the required wall thickness whereas 24% cannot fulfill the requirement (Figure-4).

The present study reveals several instances of noncompliance with the regulatory requirements. The major noncompliance is the room size. Besides, 62% facilities used the shielding material whereas 12% are partially shielded and 26% facilities have no shield against the radiation as shown in Figure-4. Among the 62% of shielded facilities, five (13-17) facilities have higher dose rate which is due to non-uniformity of shielding material. From Figure-2 it is seen that facilities 18-34 have no shielding. But the dose rate variation is found impractical in the facilities of 18-22. This is because those facilities used old machine and hence operate in lower KVp and mA. The dose rate varies with room size unexpectedly which is presented in Figure-3. This may happen due to positions of machines in the room, beam filtration etc. and non-calibration of the machine as well.

**Figure 4:** Percentage of facilities compliance with wall thickness, room size and shielding

As the Government has established a new independent regulatory body "Bangladesh Atomic Energy Regulatory Authority (BAERA) which could play a strong role in order to implement the regulatory requirements by organizing periodic safety audit, unannounced inspection, training for public awareness on radiation safety and taking steps to enforce the provisions of the Act and rules through which the radiation safety of occupational, public, patient and the environment will be ensured and hence will be the strongest radiation safety infrastructure throughout the country as it is required by the national and international organizations.
